Source Control Measures

Upper Animas River Basin

Gold King Mine Site Operations

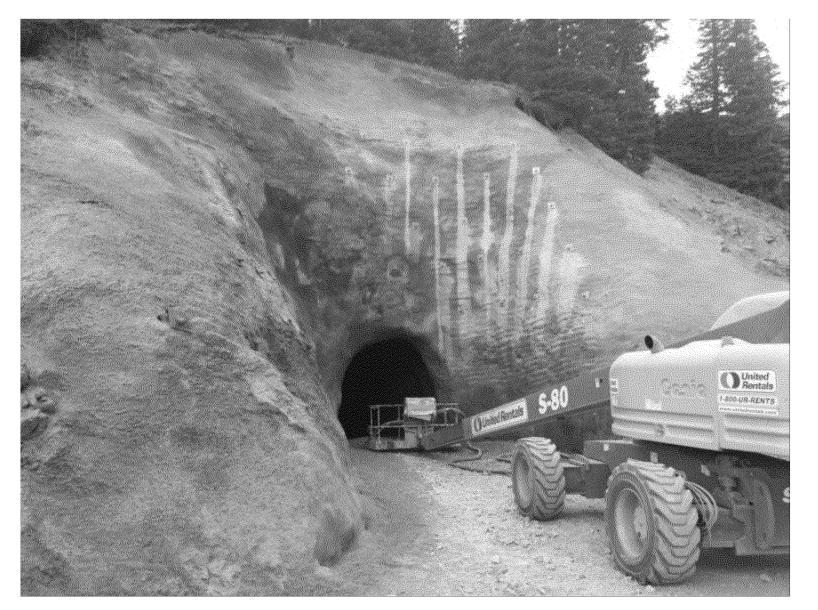
Gold King Mine Adit: Shotcrete Stabilizing Opening

- Stabilizing mine access to establish control of water flow over the winter.
- Piping water discharge approx. 4600 feet from mine to treatment ponds at Gladstone.
- Further entry and stabilization will occur next season.

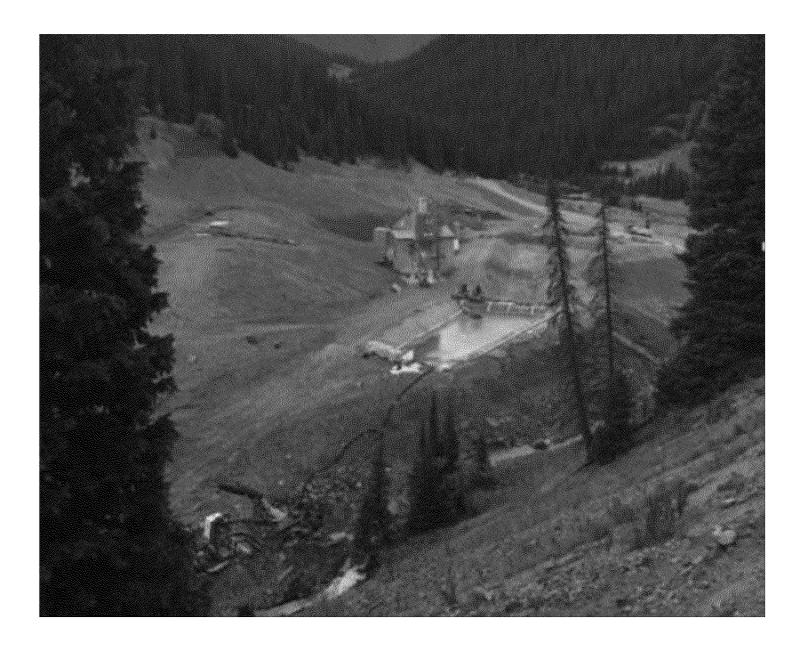
Treatment Pond at Gladstone

- Temporary treatment plant being installed to treat GKM discharge over winter and during mine site operations; treating ~550 gpm from GKM
- Water treatment performance:
 - Neutral pH effluent > 6.0, < 9.0
 - Dissolved solids will be reduced by removal of metals and formation of metal hydroxide sludge.
 - Total solids will be reduced by coagulation, flocculation, and settling through the clarifier.
 - Color is currently caused primarily by iron oxidation, and staining is caused both by iron and manganese in the mine water forming precipitates on rocks and in sediments. The treatment process will remove both iron and manganese by more than 90%, reducing the potential for color.
 - For metals of concern, the treatment process typically removes metals between 95% and 99%.
